# Town of Oak Creek

Tramway Park Preliminary Master Plan

December 31, 2017 (Draft)

GEOTECHNICAL INVESTIGATION AND PRELIMINARY SLOPE FAILURE EVALUATION

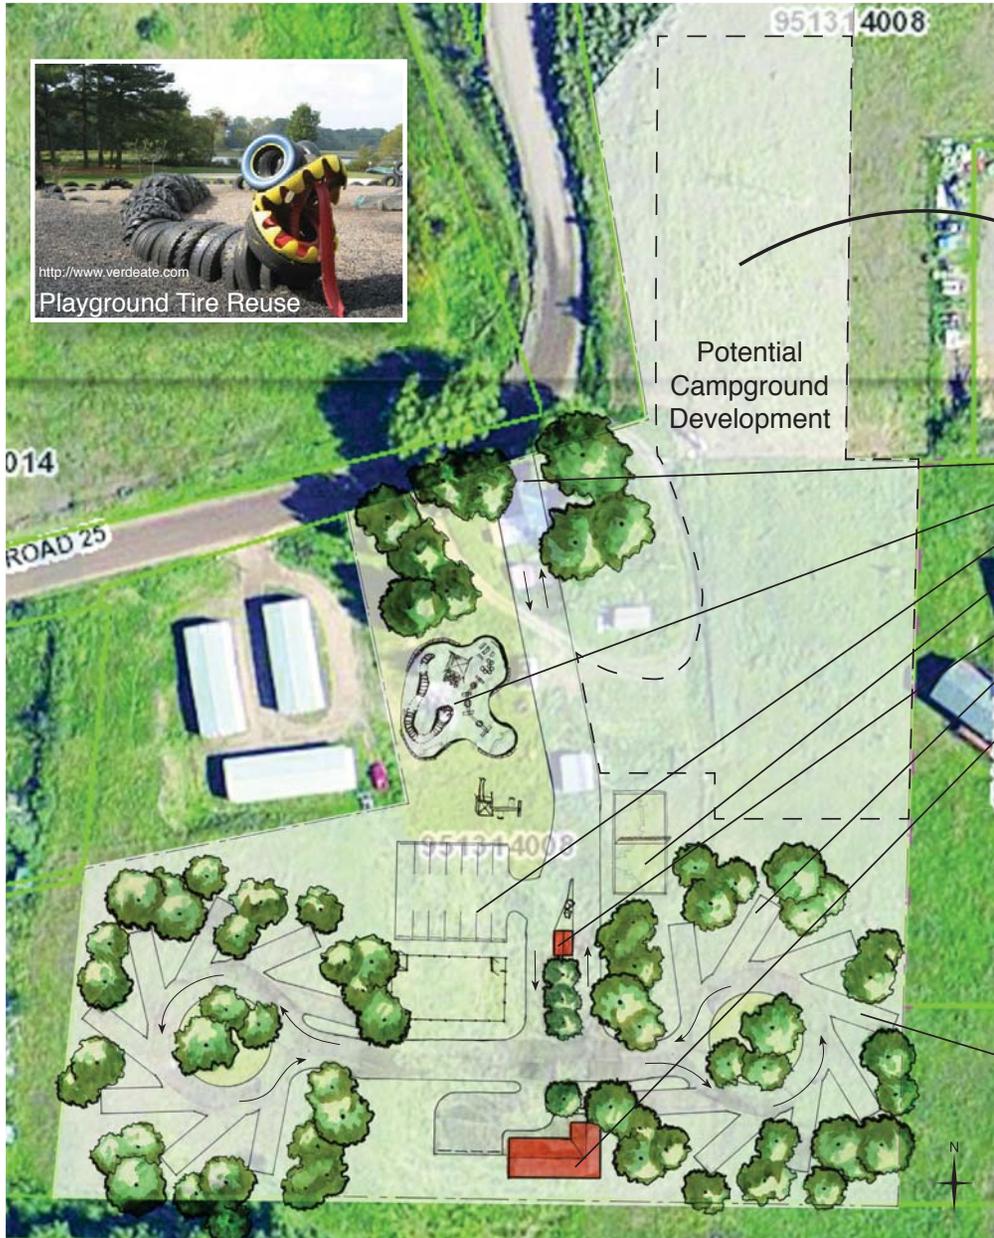
FIGURE 2 – RV PARK CONCEPT PLAN – OAK CREEK RECREATION MASTER PLAN,  
P. 33

- Entrance
- Community Play Area
- Public Parking
- Volleyball Court
- Entrance Station
- Back-In RV Sites (8)
- Bathroom, Shower, and Laundry Facility

The design on the left (above) is a tent-campground concept. The design on the right is a trail and open play area. Both of these designs can be placed in different areas of the whole RV site. They are also both simple developments that could be moved if the town needs more space for the water plant to the east.

### RV Park

The area east and south of the storage units off of CR25 has been identified by the City of Oak Creek as an area for potential development of a new tent and RV campground. The intent of the campground is to allow for more tourists (hikers, bikers, hunters, fisherman, etc.) to be able to stay in Oak Creek and contribute to its local economy.

The Oak Creek Recreation Master Plan, Spring 2014 (Rec Master Plan) identified certain uses for Tramway Park (see Figure 2). An RV Park, tent campground and common amenity building/area are identified as desirable for this remainder property, noting that the intent of the campground would be "to allow for more tourists (hikers, bikers, hunters, fisherman, etc.) to be able to stay in Oak Creek and contribute to its local economy" (p. 33.) This endeavor is further specifically supported in the Comp Plan which states that the Town should "[d]evelop the town-owned property southwest of town limits as an RV park, campground, and public park" (p. 48.)

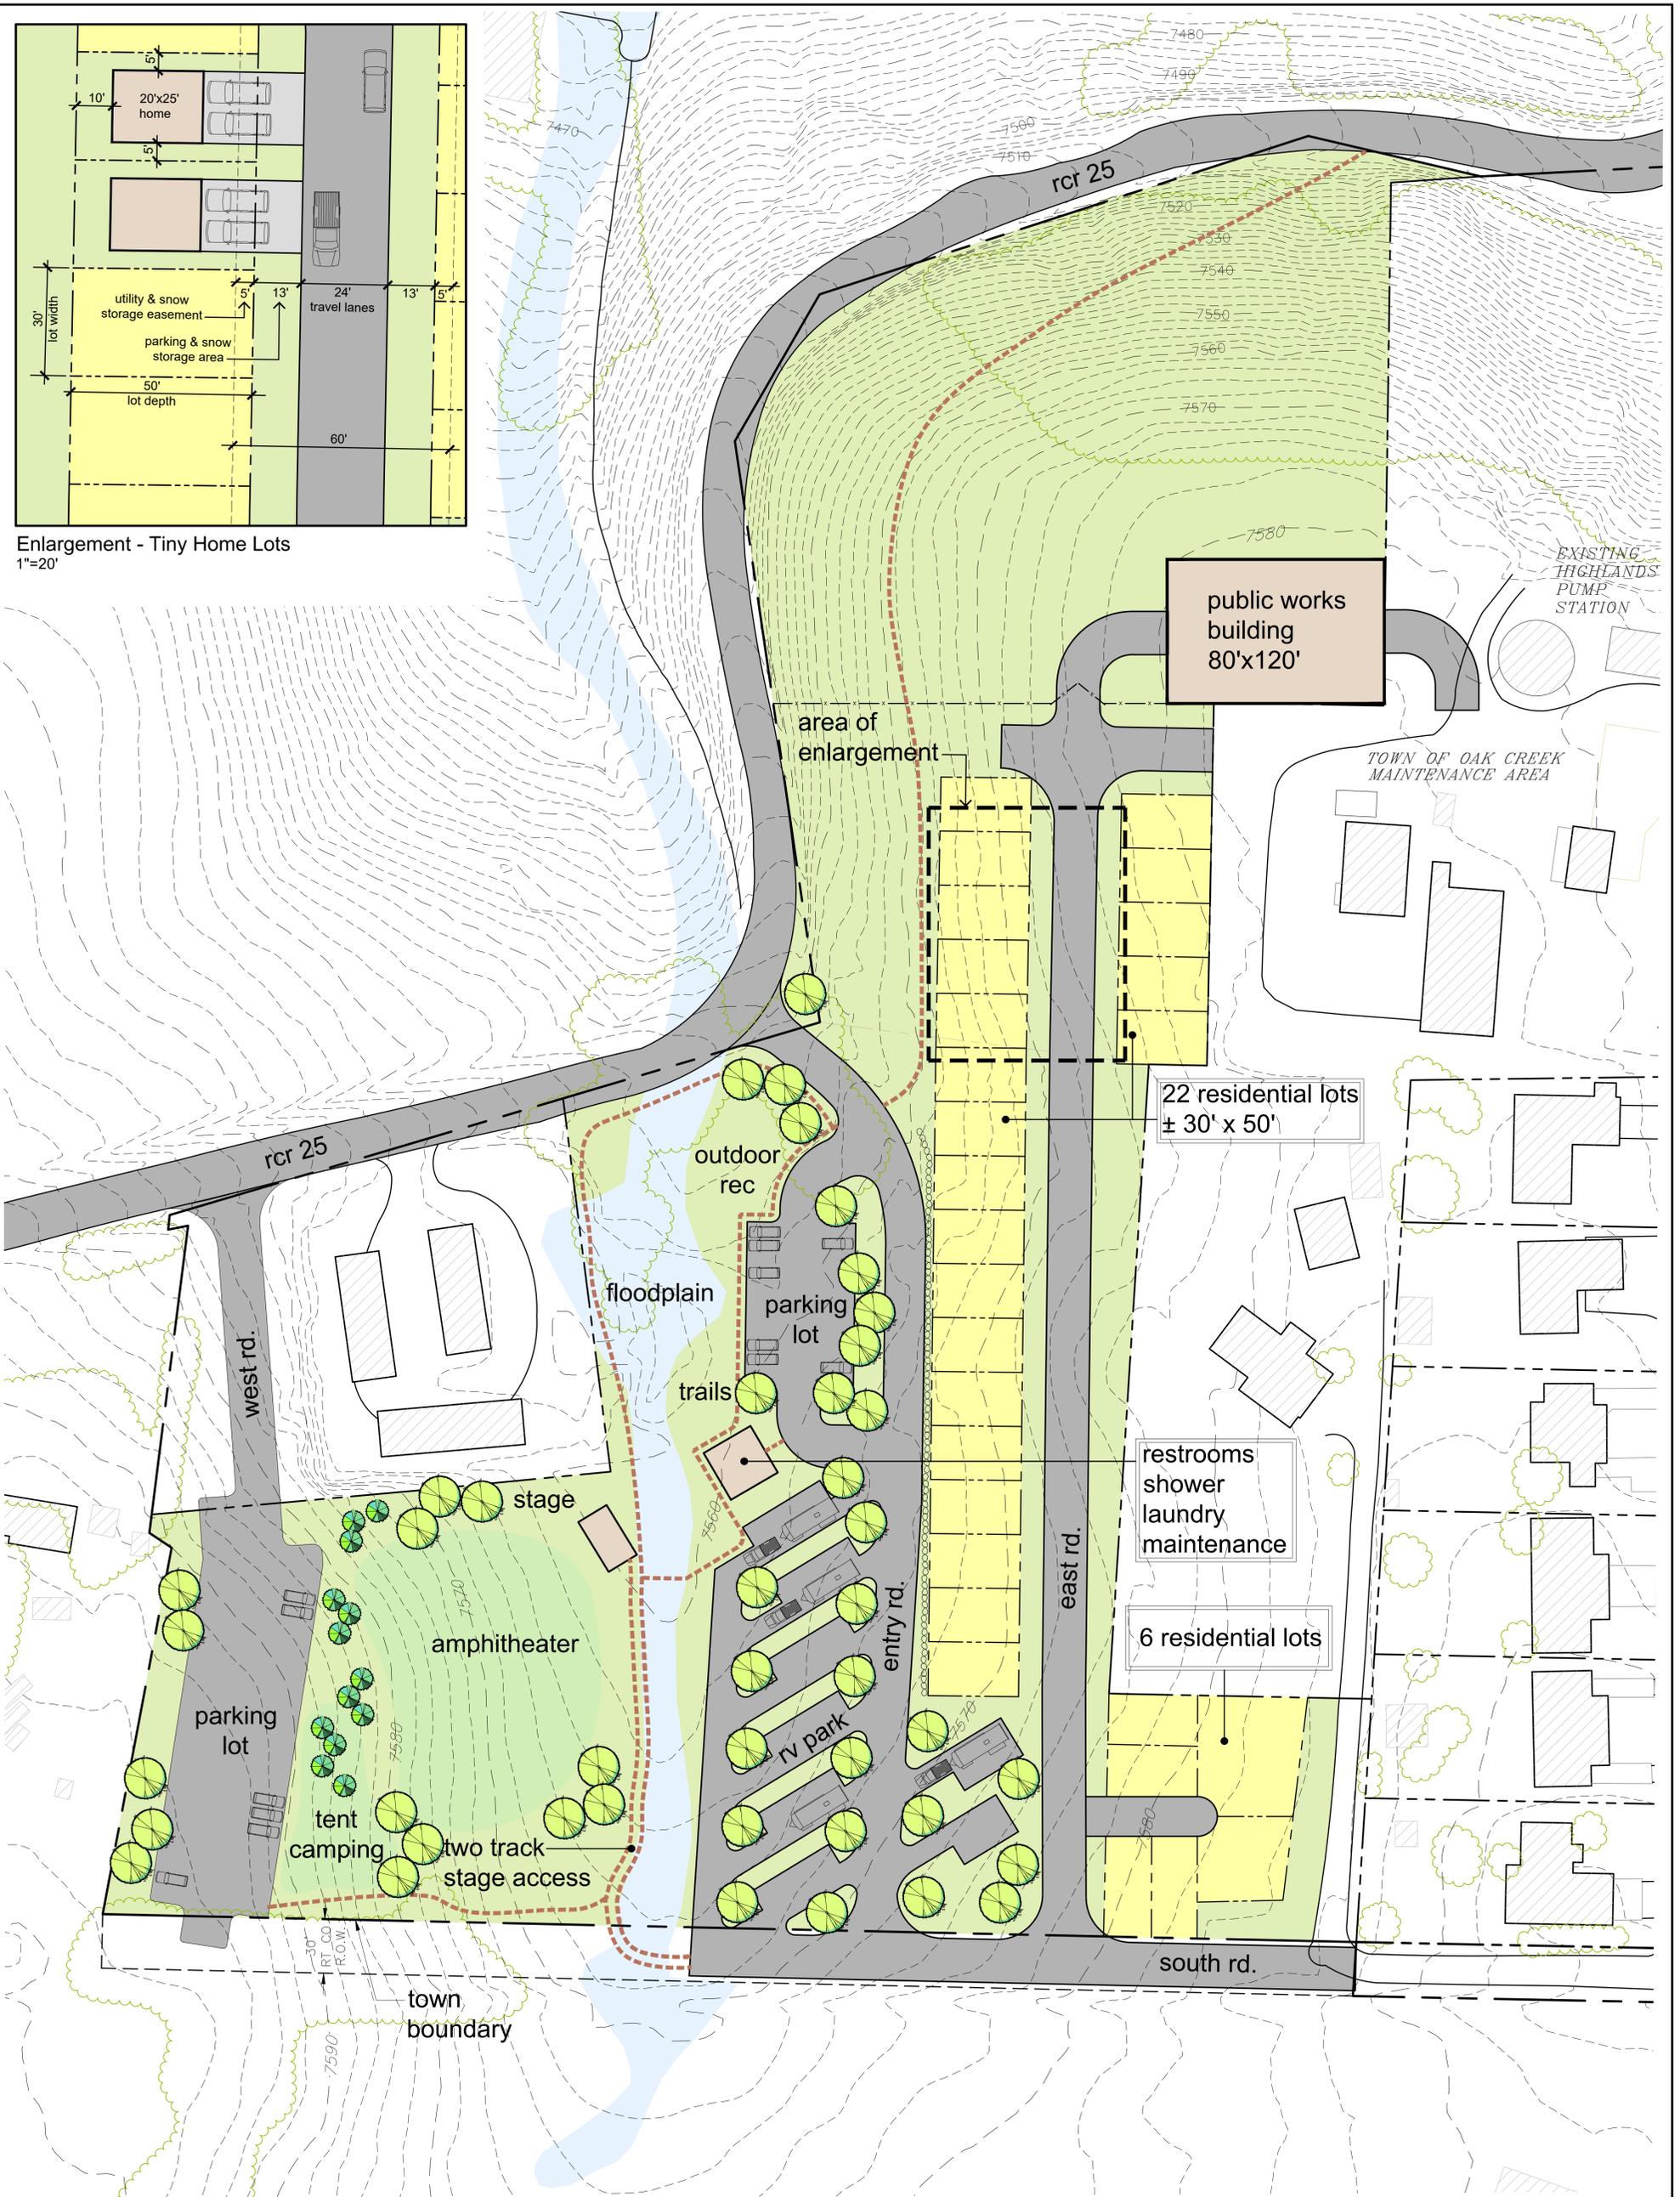
# Tramway Park

Conceptual Site Plan  
Oak Creek, CO

A Conceptual Site Plan (Site Plan) included as Figure 3, incorporating the guidance provided in the Rec Master Plan and Comp Plan, the site constraints and opportunities analysis, and the infrastructure needs and requirements assessments, was developed in coordination with Town staff. Some highlights include:

The Consultants incorporated the information gathered during their assessment as well as the guidance provided in the Rec Master Plan and Comp Plan and developed the Conceptual Site Plan (Site Plan) included as Figure 3. The December work session provided a forum to refine the project and next steps that are needed to facilitate its successful development.

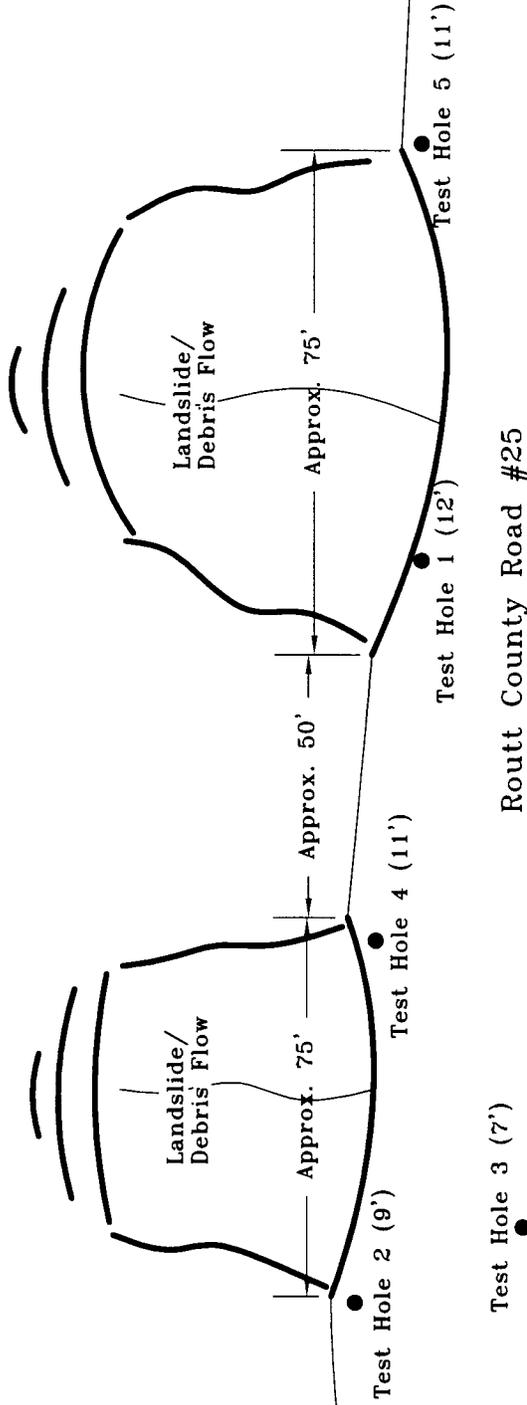
| <b>Title:</b> SITE PLAN/LOCATION OF TEST HOLES | |

(12') = Indicates Depth to Bedrock  
● Test Hole 1 = Indicates Approximate Test Hole Location and Number

The subject site is located along County Road #25 and approximately 700 feet from its intersection with South Bell Avenue in Oak Creek, Colorado. A site plan showing existing features and approximate locations of the test holes is shown in Figure #2.

The field investigation was conducted on June 29, 2011 and five (5) test holes were advanced within the right-of-way for County Road #25 at the approximate locations shown in Figure #2. The test holes were advanced through the existing fill materials, overburden soils and underlying bedrock materials with 4-inch diameter continuous flight power augers using a CME 55 truck-mounted drill rig.

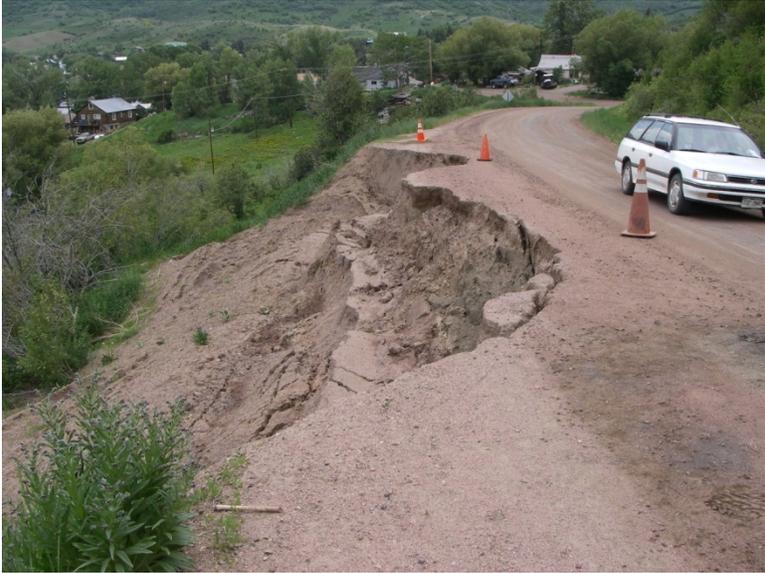
# County Road #25 Slide

June 29, 2011, Looking to the east

The far northern reaches of the Parcel have a steep topography with CR25 located at its toe. The north side of the adjacent CR25 in this area (downhill) has experienced slope failure in an area consisting of man-made fill materials placed over natural soils. It also appears that some slope movement has occurred on the south side (uphill) of the existing roadway adjacent or within this steep area of the Parcel (reference Appendix A).

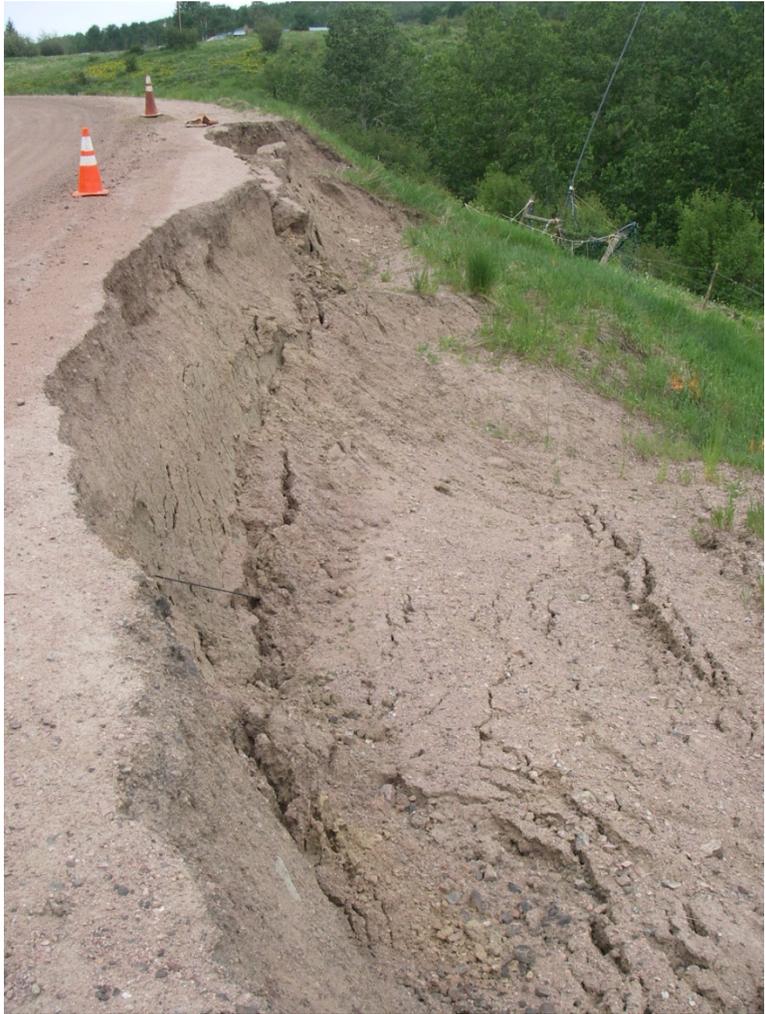
June 29, 2011, Looking to the west
